TRECOM TECHNICAL REPORT 63-42

SUMMARY REPORT
HIGH-PERFORMANCE-HELICOPTER PROGRAM
PHASE I

September 1963

BELL HELICOPTER COMPANY
Fort Worth, Texas

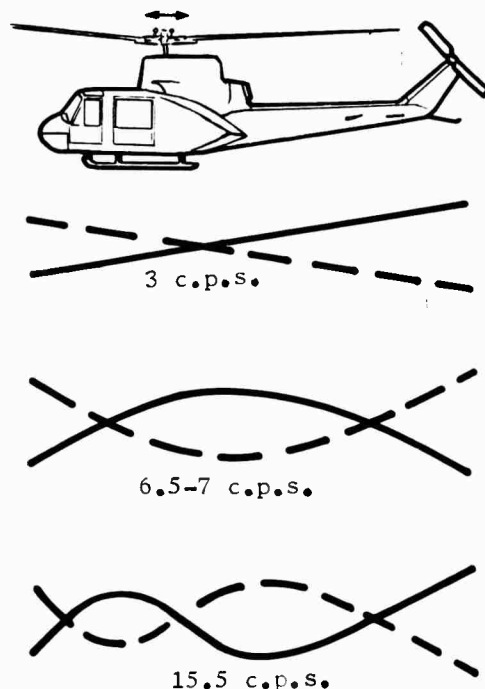
FUSELAGE LONGITUDINAL NATURAL
FREQUENCIES AND MODE SHAPES

The longitudinal natural frequencies determined by these tests are shown in the adjacent sketch. The measured lateral natural frequencies were 4.25 c.p.s. (rigid pylon-fuselage roll) and 7.0 c.p.s. (rigid fuselage-pylon bending).

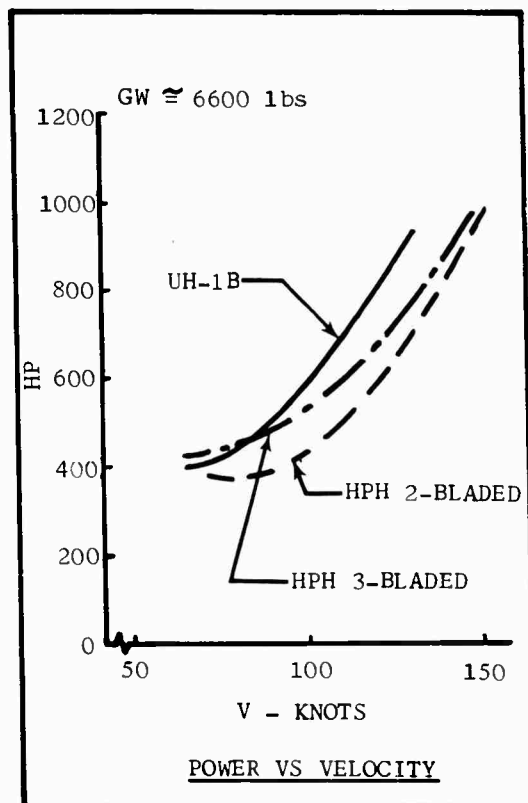
A comparison of the power versus velocity for the UH-1B and the test vehicle with two-bladed and three-bladed rotors is shown in the inset. Predicted values (from Reference 3) are shown on Figures 18 and 19. For the two-bladed helicopter without the stabilizer bar (Figure 18), the agreement is satisfactory, although slightly on the low side. The discrepancy is partially explained by the fact that in Reference 3 a fuselage parasite drag of 9.5 square feet was used, which is about 1.5 square feet less than believed to be the actual value for the research vehicle in the configuration tested.

For the three-bladed rotor helicopter, the predicted power is considerably lower than the measured power. This difference is due to the drag of the unfaired blade grips and hub of the three-bladed rotor and

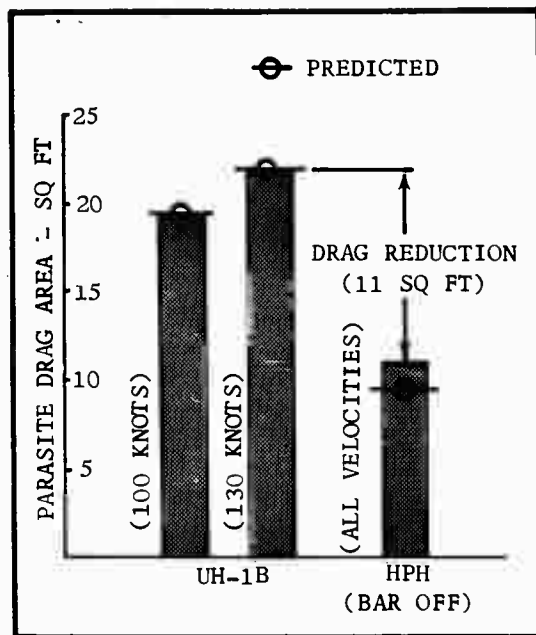
DRAG COMPARISON

Actual drag values for the UH-1B were obtained from the fuselage attitude data of the Category II tests (Reference 10) and the full-scale wind-tunnel test drag data of Reference 2. Actual drag values for the high-performance helicopter are based on the flight test results of the program. It is seen that the apparent drag of the UH-1B increases with speed as predicted. This is due to the increased nose-down fuselage attitude and the resulting increase in download. Also indicated on the graph is the over-all drag reduction of 11 square feet achieved with the high-performance helicopter. This value is slightly less than predicted due to the additional drag of the unfaired rotor grips.

The bar graph on the following page shows the estimated and actual parasite drag areas for the UH-1B and the high-performance helicopter. The estimated drag values for the UH-1B are taken from Reference 3.

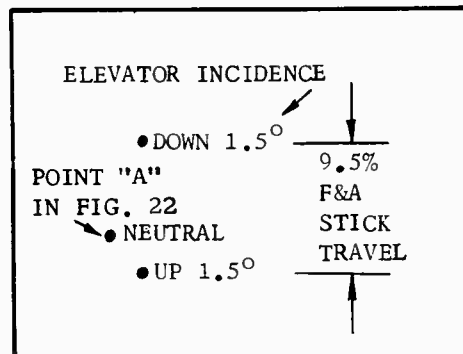
EFFECT OF ELEVATOR TRIM AT 80 KNOTS - TWO-BLADED ROTOR

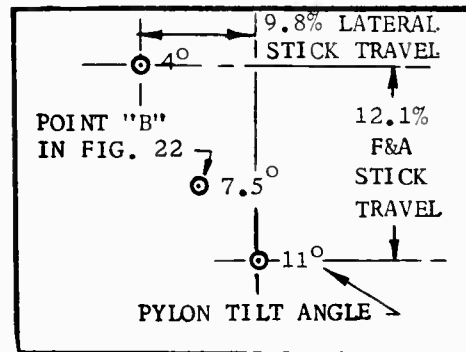
EFFECT OF PYLON TILT IN HOVER TWO-BLADED ROTOR

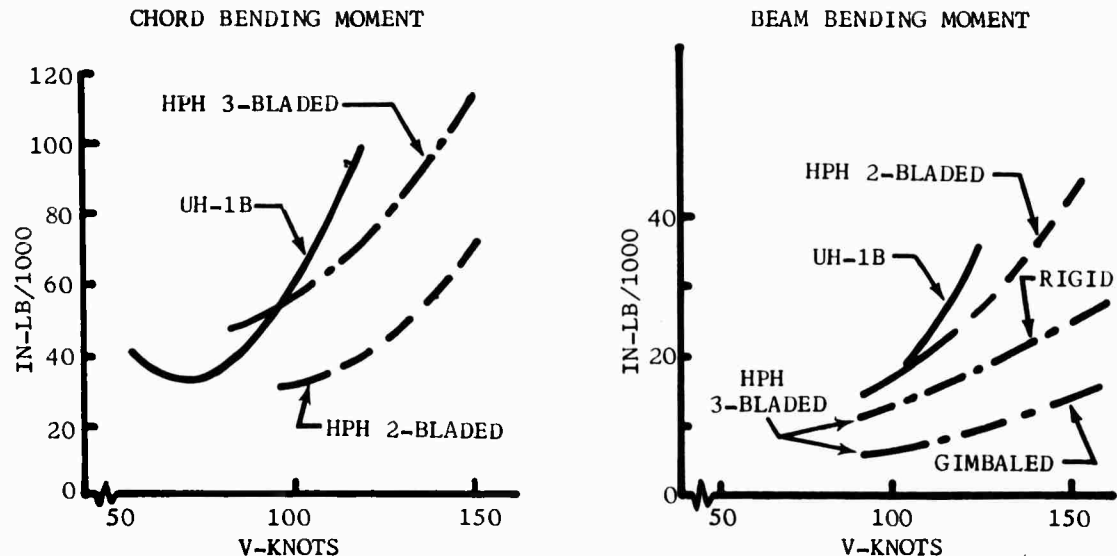
The oscillatory loads of the two-bladed rotor show the influence of drag and download reduction by comparison with the standard UH-1B test results.

The three-bladed chord loads on the test vehicle are higher than the two-bladed but still lower than the loads on the standard UH-1B helicopter. The oscillatory beam moments of the two-bladed rotor are slightly lower than the UH-1B rotor loads. While the flexure in the three-bladed rotors reduced the moments for the gimbaled configuration considerably, the moments for the rigid configuration are higher than those of the gimbaled rotor because of the steady fuselage moments about the hub.

The distribution of the loads along the blades followed closely the trends found on the UH-1B, and as a result only the moments at the rotor hub are presented since they are indicative for the entire rotor. Shown below is a comparison of the main rotor oscillatory chord and beam moments for the UH-1B and the high-performance helicopter.

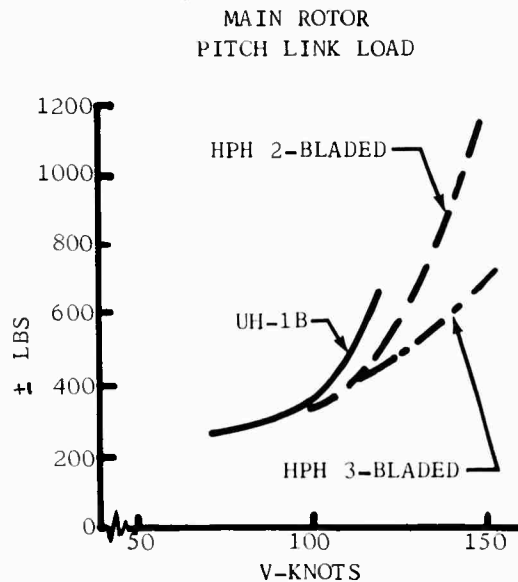
With the test vehicle, the rise in control loads occurs at higher speeds than for the standard machine. The reason for this is primarily due to the reduced fuselage download on the test vehicle, and consequent delay of blade stall effects. The additional improvement with the three-bladed rotor is due to the beamwise flexibility of the rotor yoke in-board of the pitch change axis. From these test data, it is concluded that control loads for high-speed rotors can be held within acceptable limits by the design of stiff blades which maintain their relationship to the pitch change axis.

A general comparison of the control system loads is shown below. Flight test data are given by Figure 33. At the time of the high-performance-helicopter design study (Reference 3), no attempts were made to predict control loads. Since then, methods have been developed to calculate these loads. Trends found experimentally during the high-performance-helicopter program and reported in the following discussion were confirmed

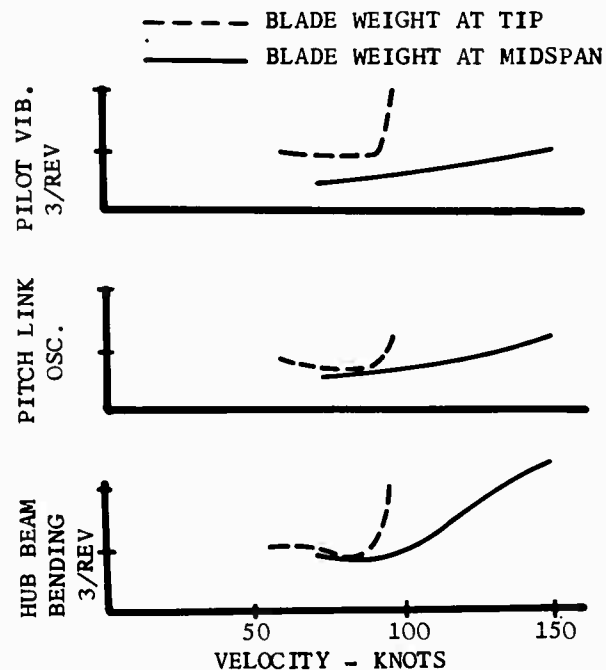
During the initial tests with the three-bladed rotor, it was found that a sudden increase in beamwise oscillatory (three-per-rev) blade loads occurred at a speed of approximately 80 knots, and also during deceleration to hover. As a quick flight test check, half of the tip weight was removed from each blade. This change was beneficial, allowing 100 knots speeds before build-up of the higher loads. A detailed computer study was conducted, and the results indicated that relocating the tip weight to midspan would prove beneficial. This was confirmed by flight tests as shown in the insert below.

EFFECT OF BLADE MASS DISTRIBUTION

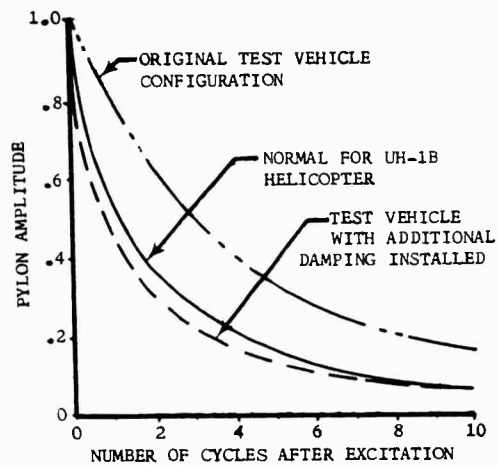
PYLON DAMPING

increase the pylon damping. The effect of this change, also shown in the insert, resulted in an acceptable degree of pylon damping. A slight increase in apparent damping was noted during flights with the hydraulic pylon actuators mechanically locked out, indicating that some reduction in damping was due to the small deflections of the pylon actuators under load. It was further found as the program progressed that the damping deteriorated. This slow deterioration in damping is believed to be the result of normal wear and looseness of the dampers and the pylon tilt mechanism.

During initial tests, it was found that pylon damping was inadequate. It is believed that the design changes associated with the pylon tilting mechanism, such as the replacement of the aft rubber mount by a metal spring, resulted in a decrease in damping compared to the standard pylon configuration. A comparison of the UH-1B and the test vehicle pylon damping is shown in the insert on the following page. Friction dampers were installed between the upper transmission case and the cabin roof to

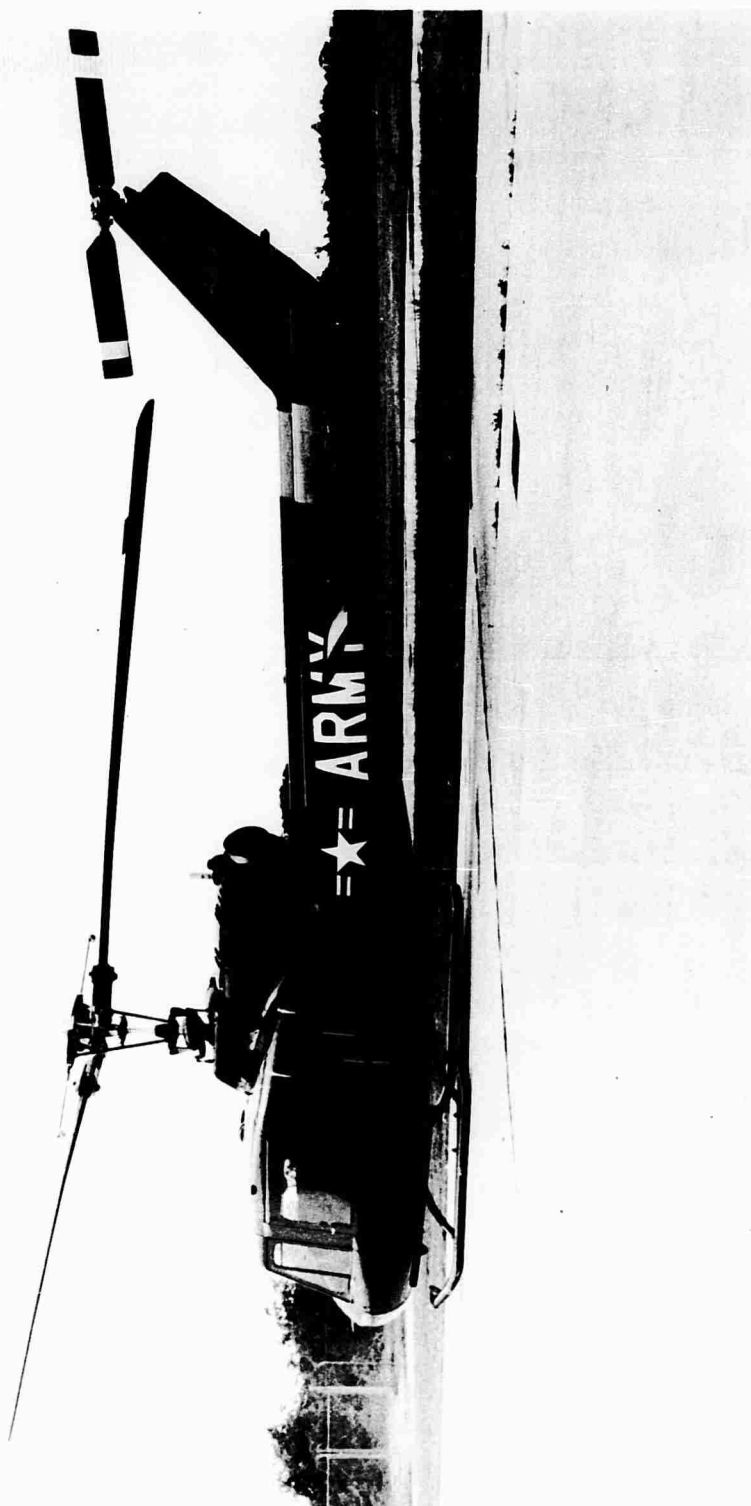
FIGURE 1 - YUH-1B HELICOPTER

The aircraft made available for the program was a YH-40 helicopter, reconfigured with YUH-1B dynamic components. This aircraft was first flown in June 1958 and had accumulated about 345 hours of flight time during numerous test programs at the contractor's facility. Figure 1 shows the test vehicle in the YUH-1B configuration prior to the start of modification into the high-performance configuration. Figure 2 shows the same vehicle after completion of its modification into a high-performance research vehicle.

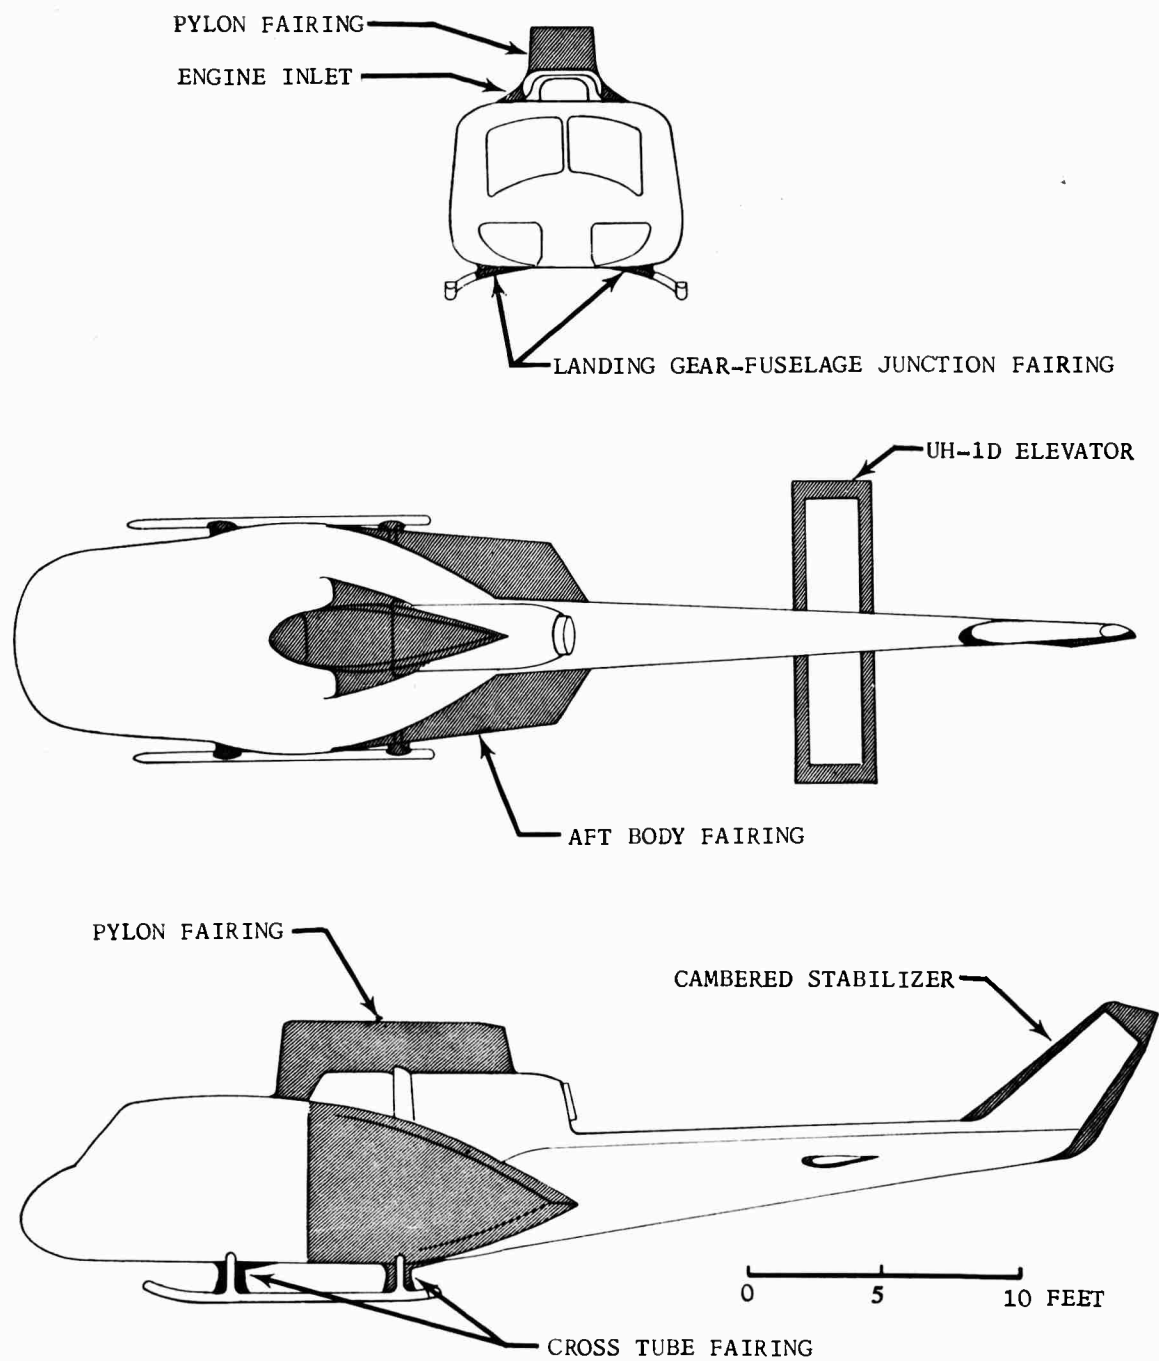
FIGURE 3 - CONFIGURATION COMPARISON OF HIGH PERFORMANCE
AND UH-1B HELICOPTERS

Aerodynamic modifications were made to the fuselage to reduce the aerodynamic download and parasite drag area. The modifications included the addition of fairings to the aft fuselage and landing gear, and around the mast, controls, and pylon. Additionally, the vertical stabilizer was modified into a cambered airfoil, and external protuberances such as mirrors, rain gutters, antenna, etc., were removed. A new engine air induction system was installed to provide increased ram pressure recovery and to prevent drag due to separation over the inlet lip at high speeds. Figure 3 shows the difference between the standard UH-1B and the high-performance-helicopter fuselage lines.

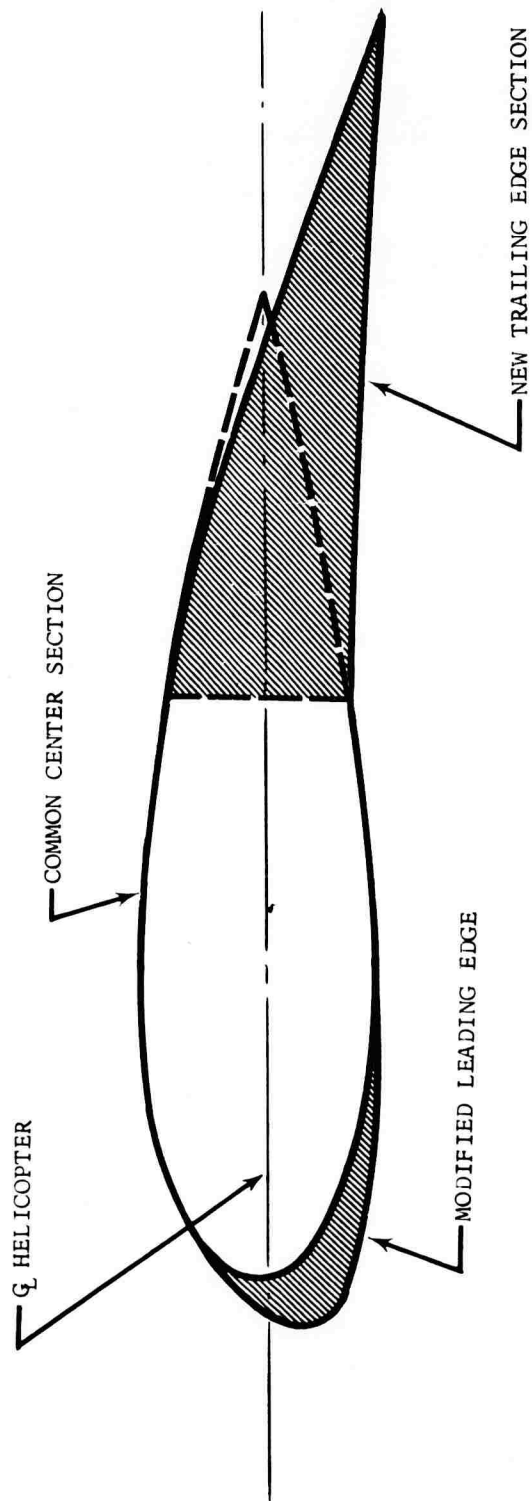
FIGURE 5 - VERTICAL FIN COMPARISON - HIGH-PERFORMANCE HELICOPTER
AND UH-1B

The vertical stabilizer was modified into a cambered airfoil section by the addition of a new leading and trailing edge. Figure 5 is a comparison of the standard fin and the cambered fin of the test vehicle. The purpose of the cambered section is to reduce tail-rotor flapping motions and loads at higher speeds by utilizing aerodynamic lift to supplement the tail-rotor thrust in counteracting main-rotor torque. The tail-rotor gearbox is covered by a removable fiberglass fairing. Cooling air for the gearbox enters at the leading edge and exits through louvers near the trailing edge.

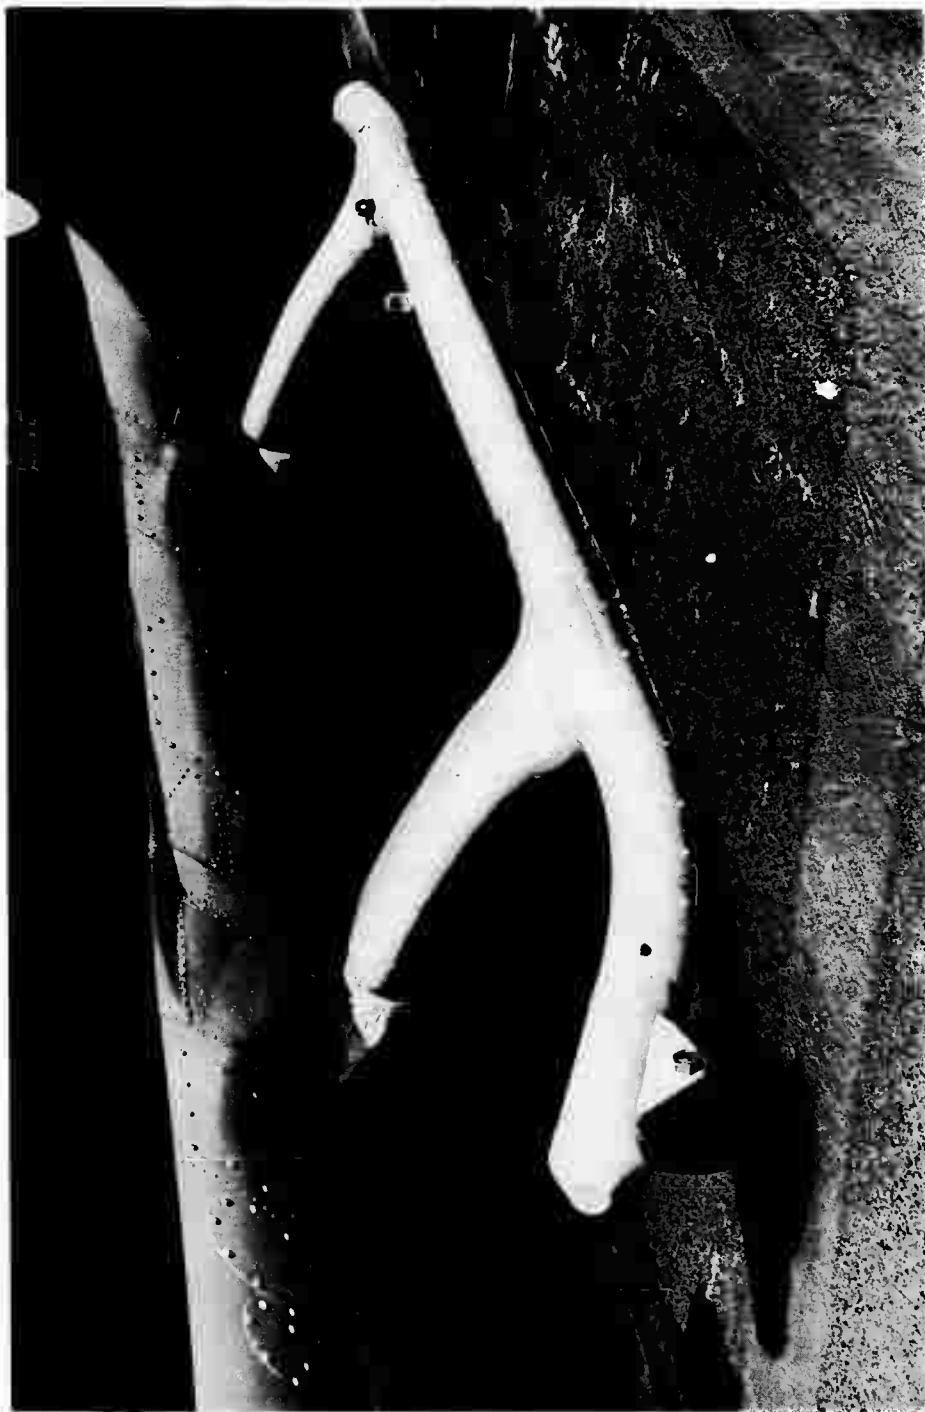
FIGURE 6 - FAIRED LANDING GEAR WITH TAKEOFF WHEELS

junction fairings are positioned such that they align with the fairings installed on the cross tube in flight when the landing gear is unloaded. Figure 6 shows the faired landing gear with the ferry mission takeoff wheels installed and also shows the misalignment of the cross tube and junction fairings when the gear is loaded.

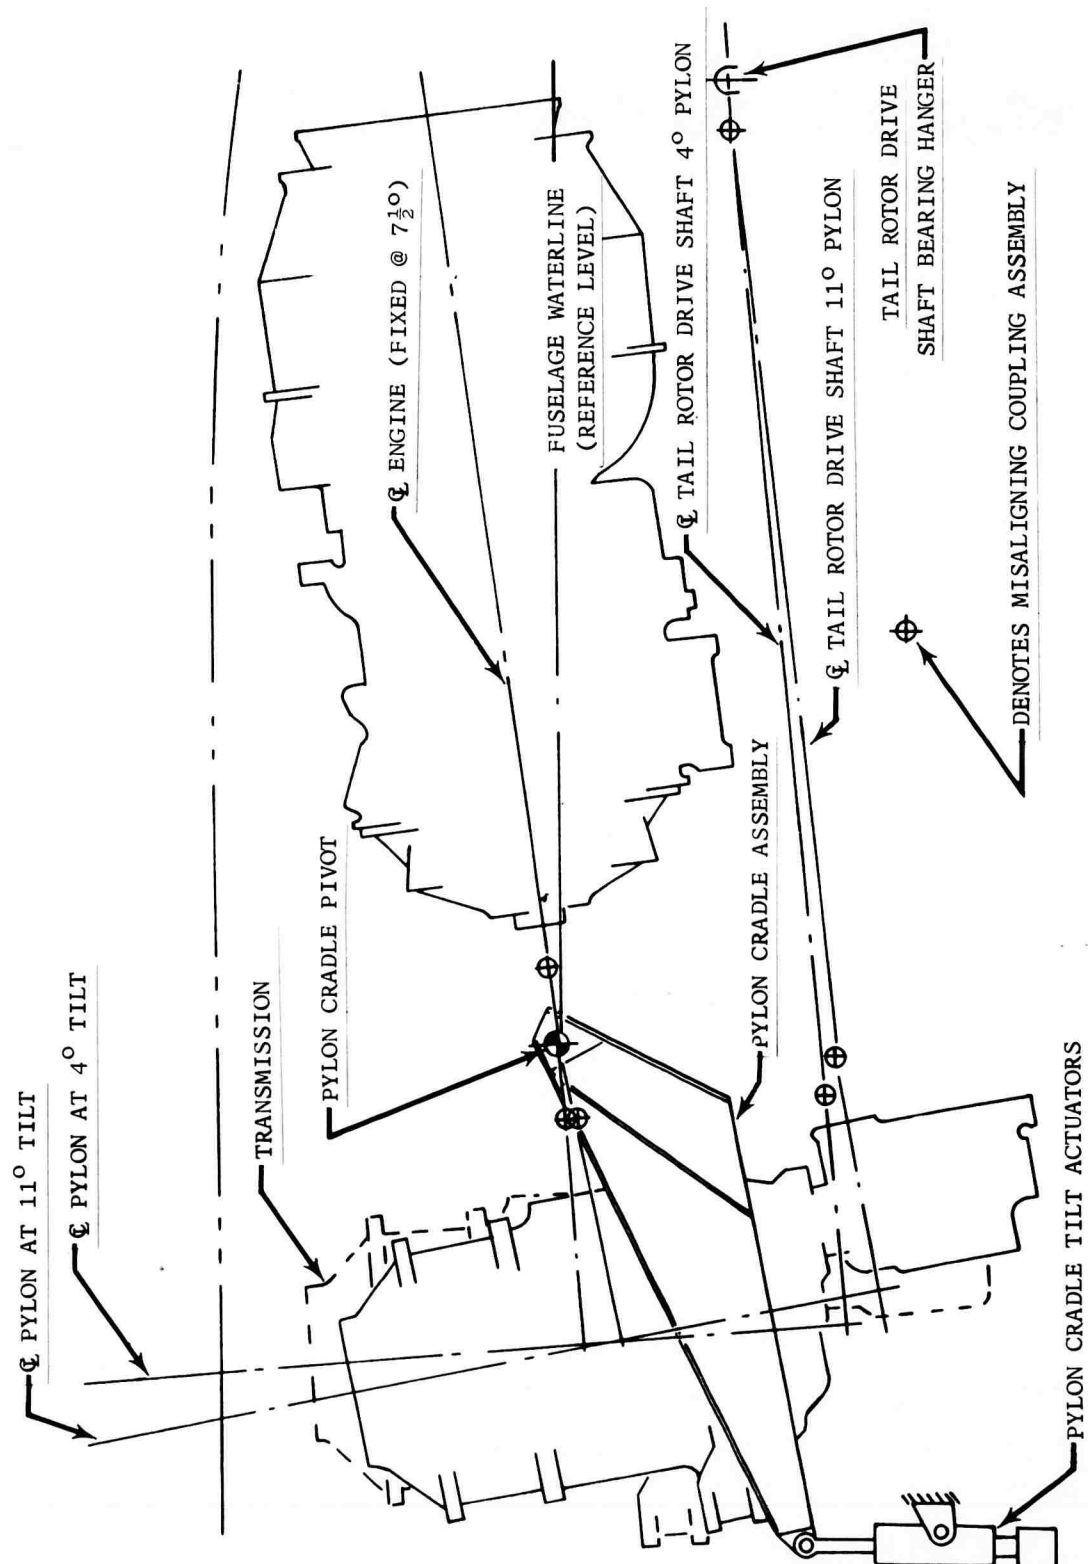
FIGURE 7 - GEOMETRY OF TILT PYLON SYSTEM

To minimize the fuselage download and parasite drag, a tilt pylon mechanism was installed to permit in-flight adjustment of fuselage attitude. During the design phase, several concepts were investigated and a system was selected in which the pylon was mounted in a cradle which pivoted about a lateral line through the geometric center of the input driveshaft. This location of the pivot axis resulted in minimum misalignment of the input driveshaft and allowed a fixed engine position for the full range of pylon tilt without exceeding the capability of the input driveshaft couplings. Figure 7 shows the basic geometry of the system.

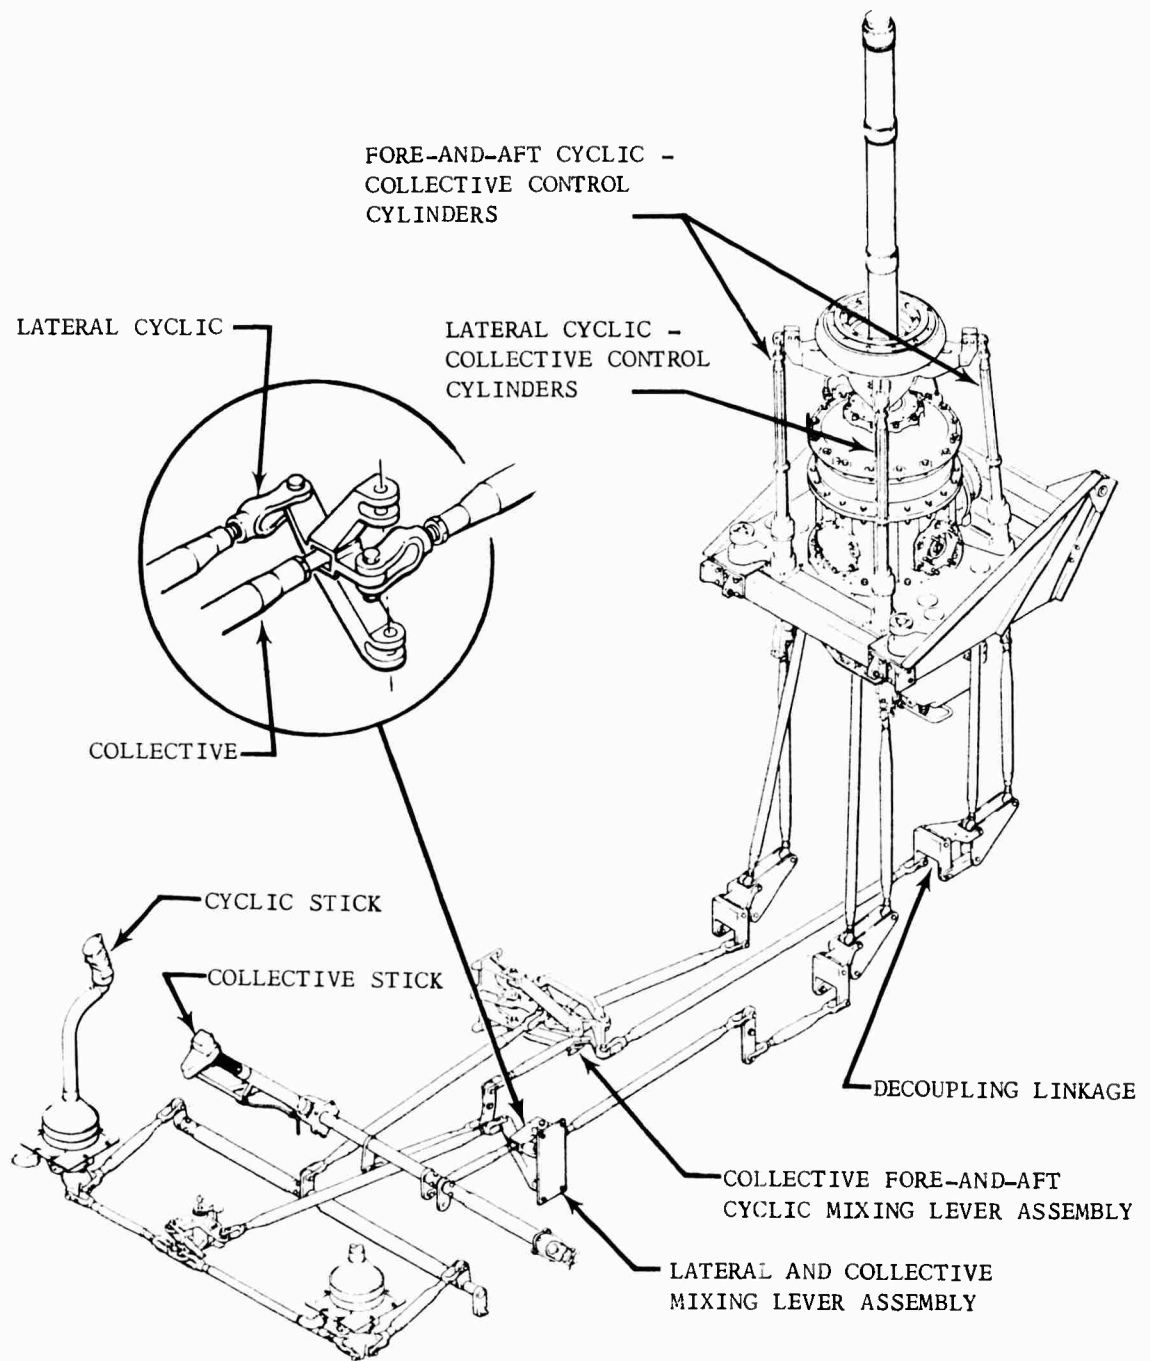
FIGURE 8 - HIGH-PERFORMANCE HELICOPTER CONTROL SYSTEM

The control system was modified to accommodate the tilting pylon system and to be adaptable for both the two- and three-bladed rotor configurations which were to be evaluated during the program. To provide a universal system which would allow the maximum utilization of components common to all rotor configurations while maintaining maximum control stiffness, the collective-cyclic mixing functions were transferred from the rotating system (pylon based) to the fixed system (fuselage based). Figure 8 shows the control system for the high-performance configuration. For comparison, the standard control system is shown in Figure 9.

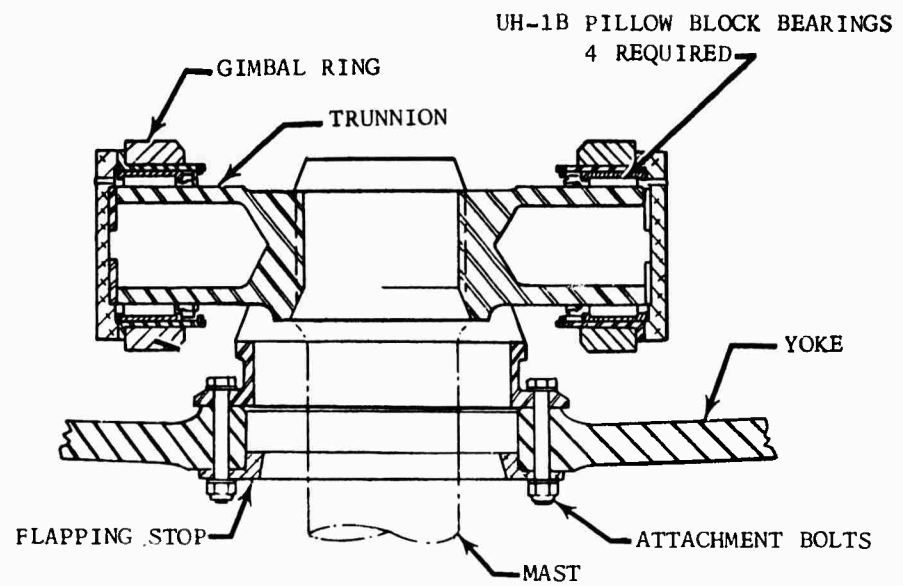
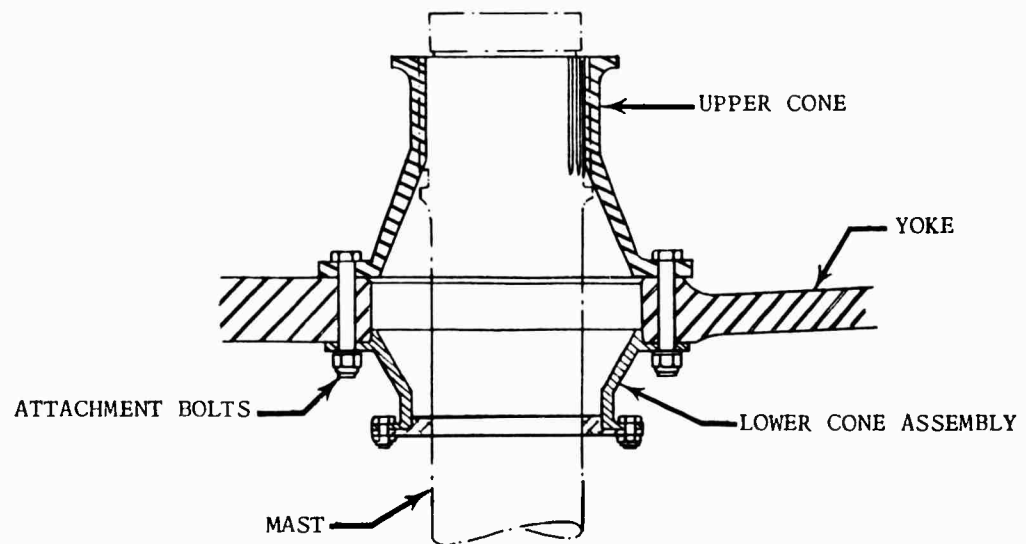
FIGURE 12 - THREE-BLADED ROTOR-MAST ATTACHMENTS

To change from a gimbaled to a rigid mount, the gimbal ring and trunnion are replaced by an upper cone, which is splined to the mast, and by a lower cone and split ring, which bear against the mast below the yoke and hold the rotor hub in rigid relationship with the mast. Figure 12b shows the rigid component buildup. By comparing Figures 12a and 12b, it can be seen that the rotor mounting may be readily changed from the gimbaled to the rigid system.

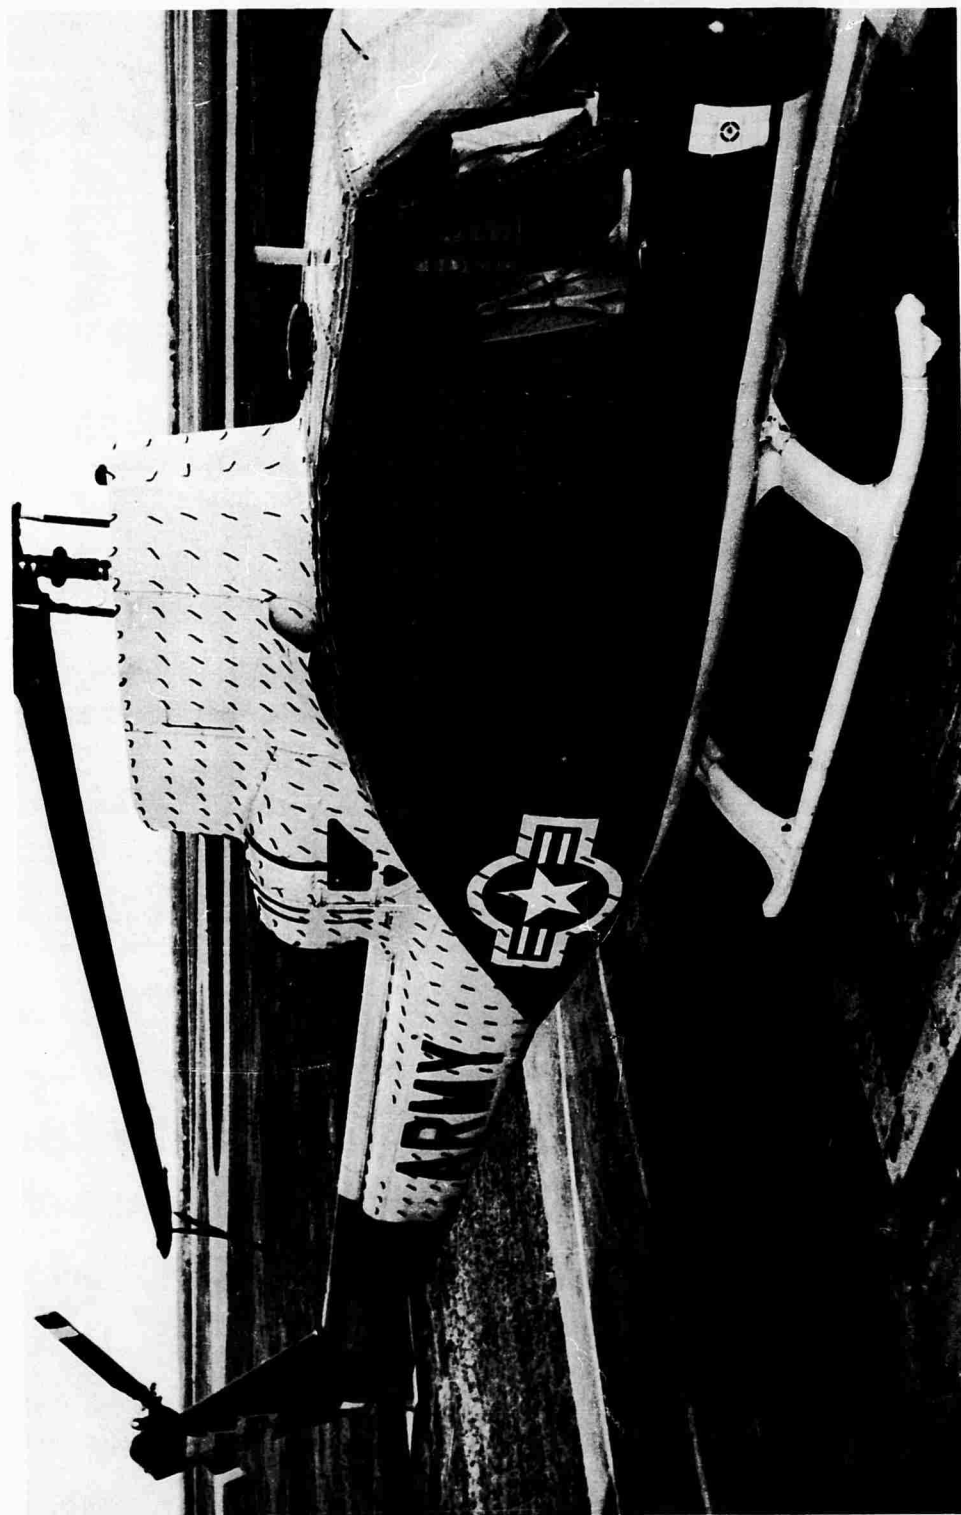
FIGURE 14 - TUFTED FUSELAGE

For the airflow investigation, the helicopter was tufted as shown in Figure 14, and the tuft behavior was observed and recorded on motion picture film throughout the helicopter speed range and for various pylon

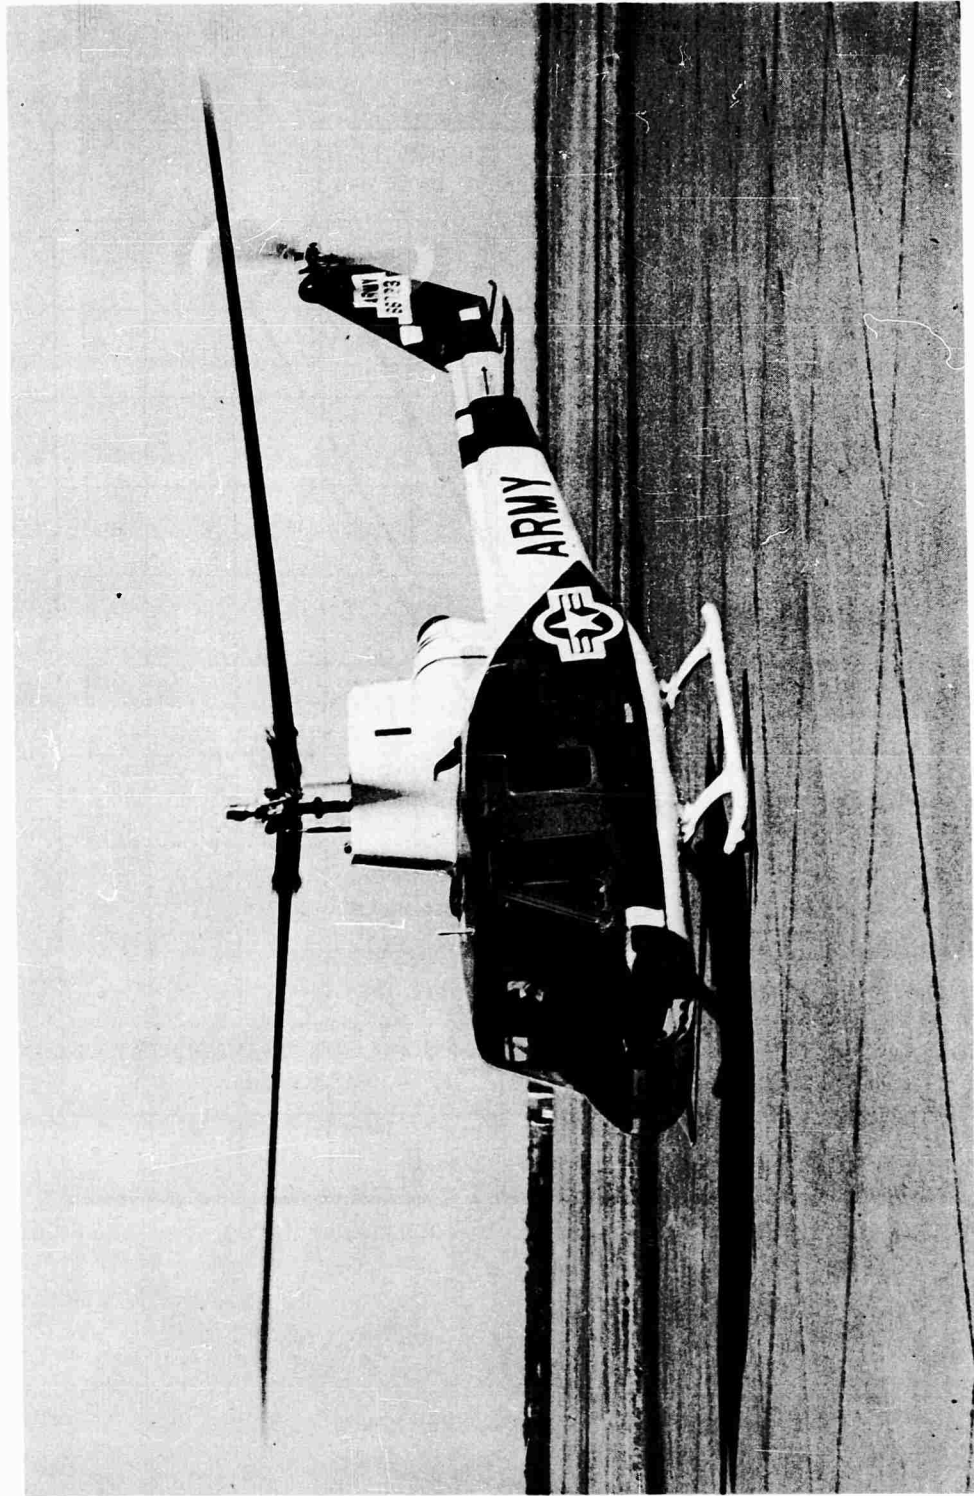
FIGURE 15 - OVERLOAD GROSS WEIGHT TAKEOFF TEST

During the evaluation of the running takeoffs, it was found that the capability of the machine used in this manner greatly exceeded the allowable landing gear loads. It is estimated that the maximum takeoff gross weight for a running takeoff exceeds 12,000 pounds for the test vehicle. Due to the landing gear restrictions, the overload takeoffs were simulated at a gross weight of about 8,000 pounds and with a power less than that required to lift the skids off the ground. Figure 15 shows the helicopter using the landing gear wheels during a simulated overload running takeoff.

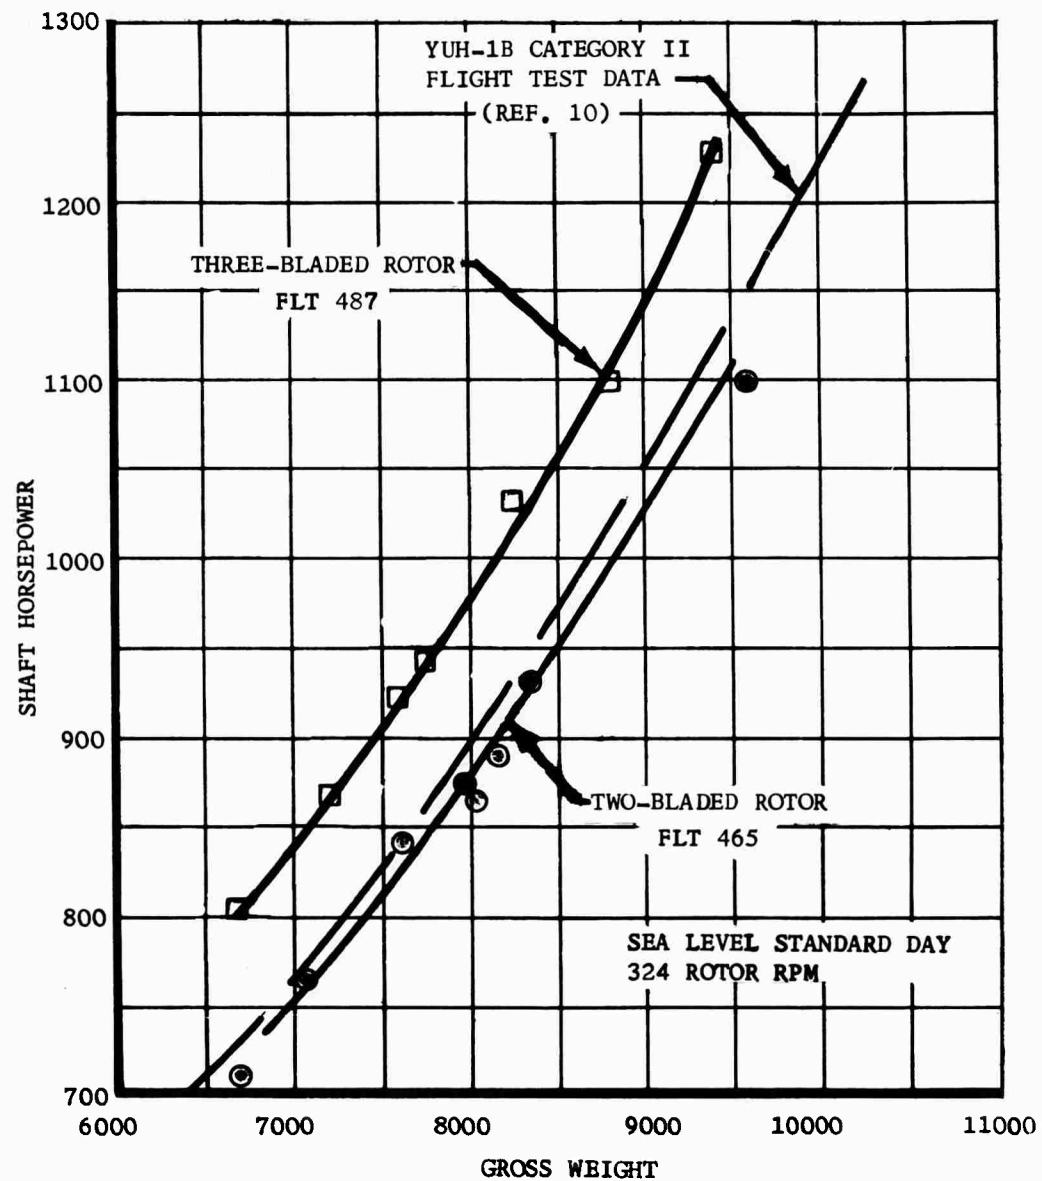
FIGURE 16 - HOVERING PERFORMANCE.

Hovering data for the high-performance helicopter with two- and three-bladed rotor configurations are shown in Figure 16. Also given is the hovering performance for the UH-1B as obtained during the Air Force Category II Flight Tests (Reference 8). All data are corrected to 324 rotor r.p.m. and to sea-level, standard day conditions. As expected, the hovering performance of the test vehicle with the two-bladed rotor is essentially the same as that of the standard UH-1B.

The three-bladed rotor is shown to require more power in hovering as compared to the two-bladed rotor. At a gross weight of 7,000 pounds, the power difference is about 85 horsepower. A simple analysis indicates that the power loss may be broken down as follows:

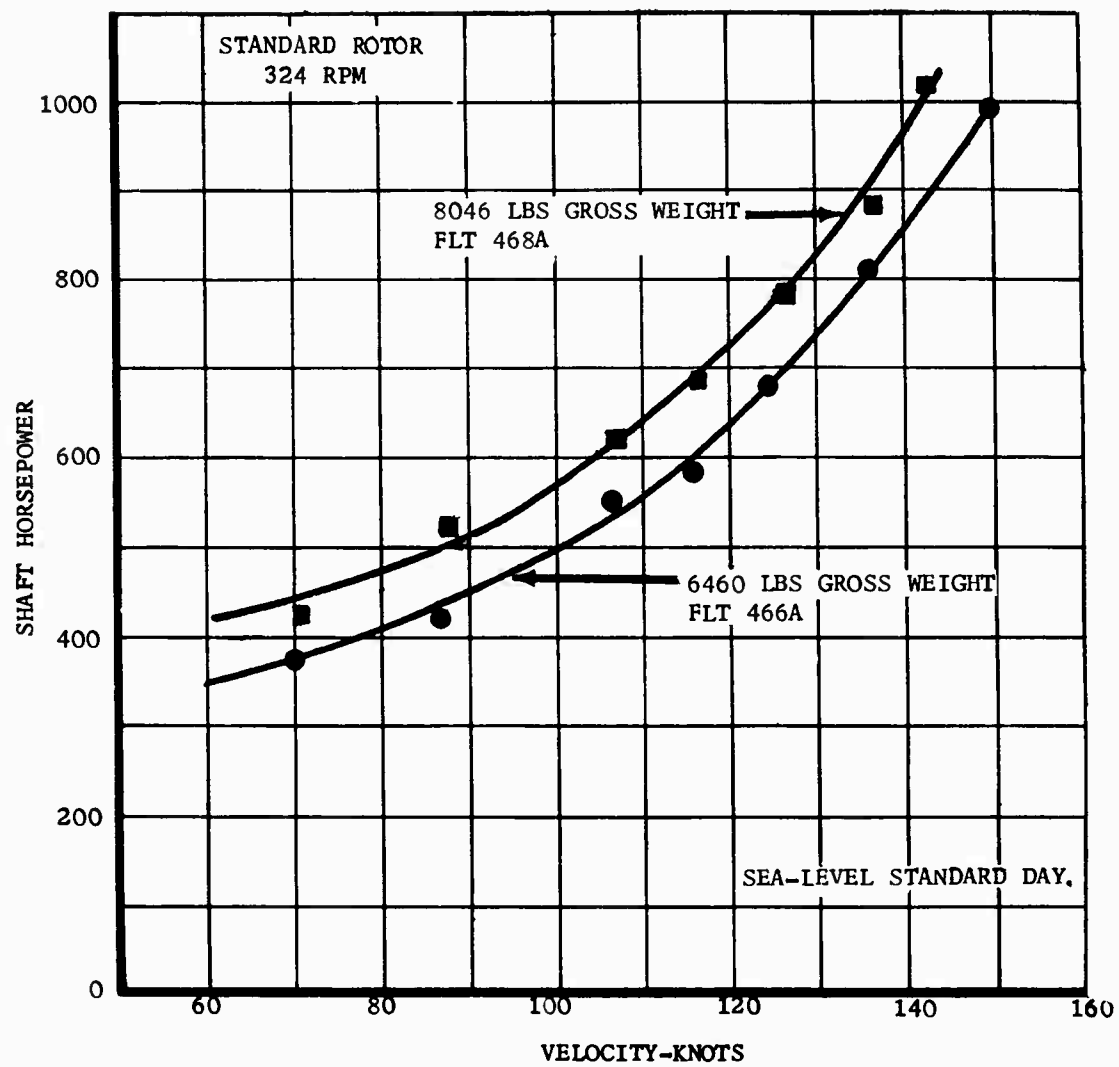
FIGURE 17 - LEVEL FLIGHT PERFORMANCE,
TWO-BLADED ROTOR

Level-flight speed power data at two gross weights for each rotor configuration are shown in Figures 17 through 20. The highest speeds were attained with the two-bladed rotor without the stabilizer bar. With this configuration, 155 knots true airspeed was attained in level flight, and 162.5 knots was attained during a shallow 4-degree dive at reduced power. The maximum airspeed with the standard rotor with the stabilizer bar was 150 knots; with the three-bladed rotor, 151 knots.

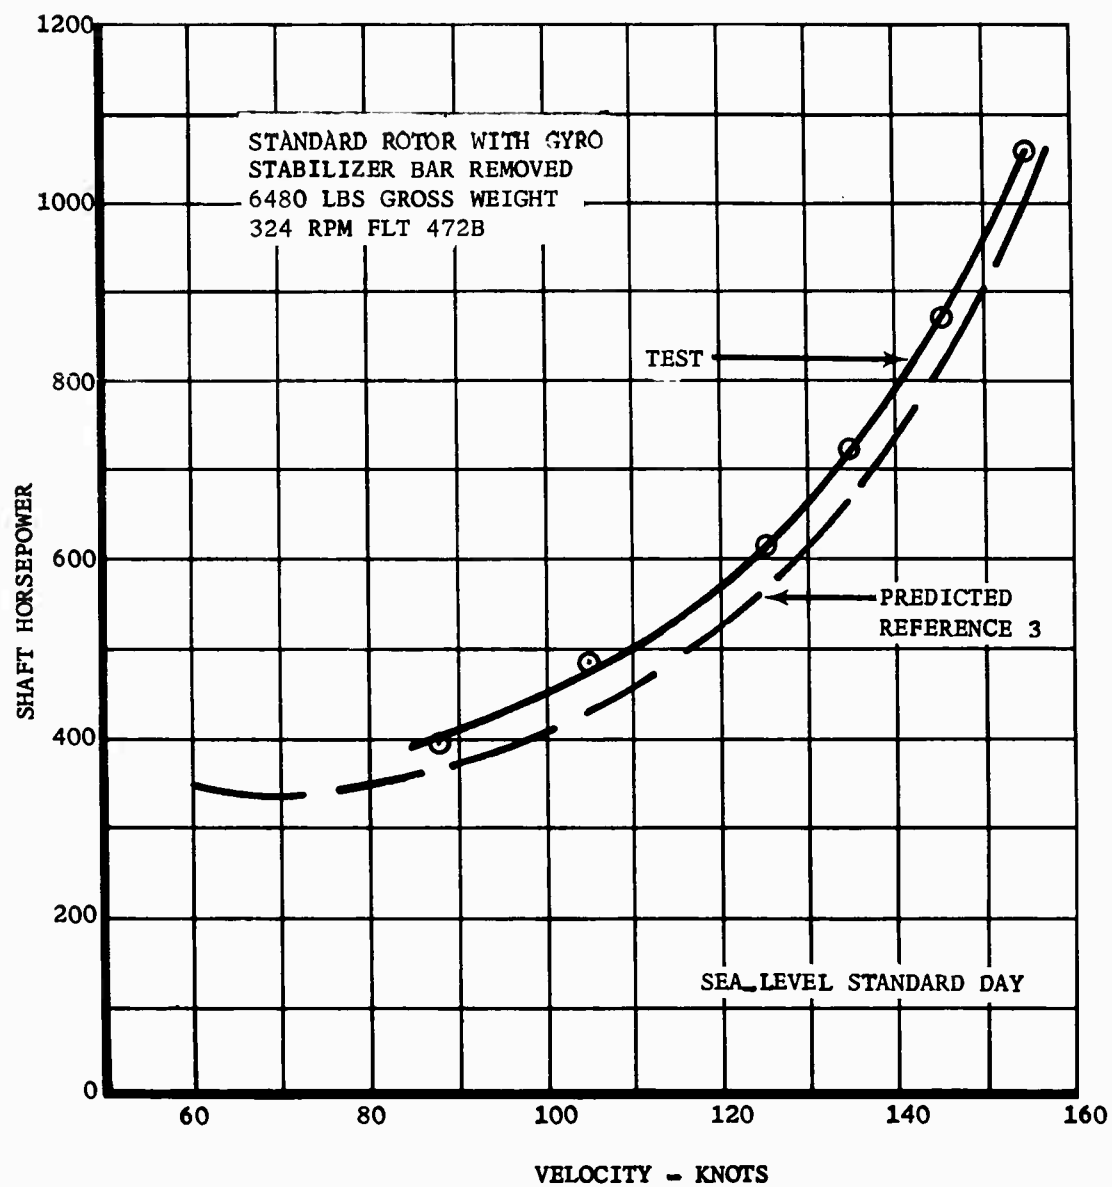
FIGURE 18 - LEVEL FLIGHT PERFORMANCE
TWO-BLADED ROTOR WITHOUT STABILIZER
